EF1630/APT

RE: MAISEMORE GARDENS DRAINAGE INVESTIGATIONS

Enc Schematic of existing drainage

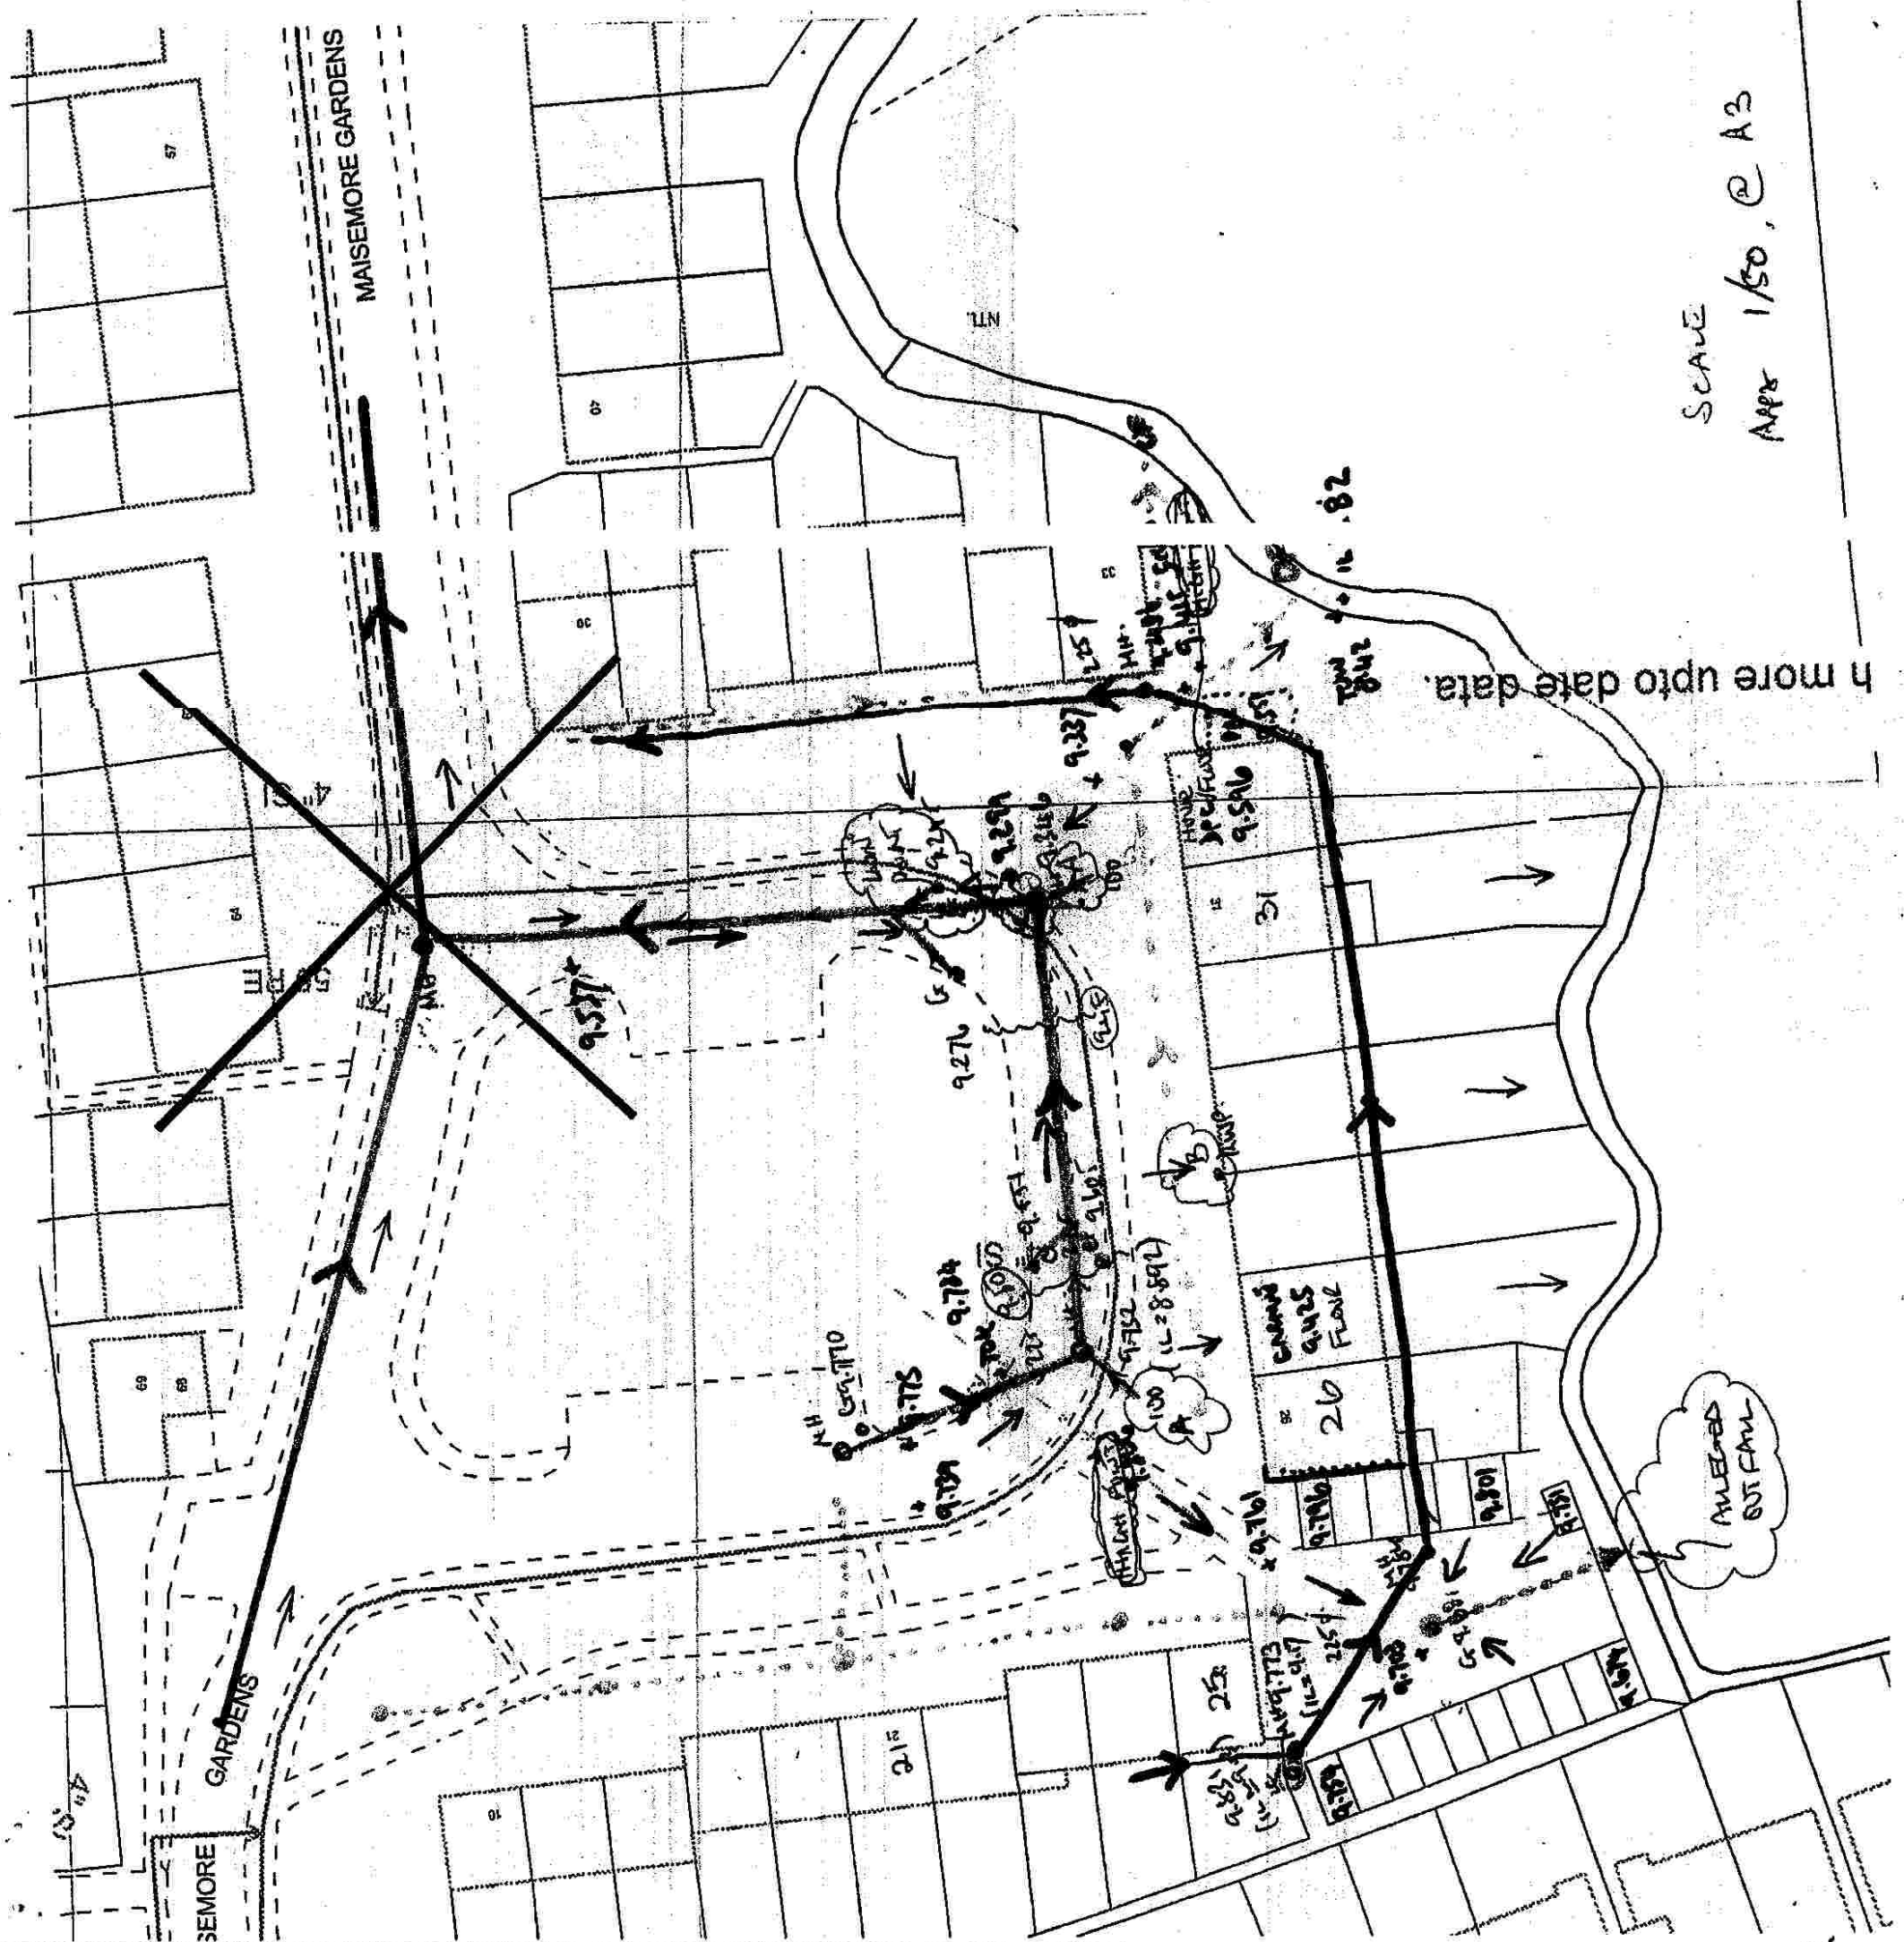
EXISTING

1. The garage blocks adjacent No 26 typically have slab levels of the order 9.75-9.80m LD (local datum) with a surfaced central yard area of the order 9.70-9.75m LD. This has a small central yard gully with cover level of some 9.68m LD. There is a slight fall from the garage slabs to the central yard gully but the gradients are slack. The gully was 100% silted up to the surface when inspected. It is not known where this drains to but a resident present in that area at the time of survey stated this discharge direct to the adjacent watercourse. **RECOMMENDATIONS:** Clean out the gully and rod/flush the outlet. Determine where this outfalls and mark on to the estate plan for future reference. Add regular cleaning out of this gully to the estate maintenance schedule.

3. The highway channel levels to the front of Nos 26-32 fall from some 9.75m LD to the front of No 26 to a low point of some 9.25m LD to the bend in front of No 32. Whilst there is good longitudinal fall on the carriageway axis it should be noted that this compares to finished floor levels of the block of 9.59m LD internal and 9.42m

5. At the highway manholes to the front of Nos 27 and 32 there are loomm DN connections from the private areas beyond the highway, which do not appear to correlate to any highway asset. It is therefore possible that the private drain is/was linked to the highway drain. There are benefits in the two systems being linked even if at higher elevation than the individual systems. This would enable each system to make some use of each other's outfall once rainfall causes the systems to surcharge. In particular this would facilitate drainage of ponded water from the low road gully across to the private system and out to the stream as discussed in (4) , above. RECOMMEDATION: Local excavation and exposure of the private network pipes in these areas, and/or digging back along the lines of connection into the highway manholes may identify the point to install inspection chamber to maintain/enable this and for future accessibility and maintenance.

A LINK FROM PRIVATE
 DRAIN TO HIGHWAY
 DRAIN?

B PROBABLE LINK
 FROM R.W.P.

C MH L.O. NOT LOCATED
 IN CHAMBER
