# ASSET INSPECTION NOTE

<b>Location Name</b>	Maisemore Gardens	<b>Coastal Policy Unit</b>	5a16
<b>Report Date</b>	26/11/2021	<b>Coastal Policy</b>	HTL – hold the line
<b>Landowner</b>	Private	<b>MWF Lot</b>	Lot1
<b>Maintainer</b>	Private	<b>Assets at Risk</b>	<ul style="list-style-type: none"> <li>• Residential properties</li> <li>• Gardens</li> <li>• Public footpath</li> </ul>
<b>Report By</b>	Amy Smith	<b>Asset Overall Condition</b>	Fair
<b>Structure Reference</b>	ASSET475	<b>Worst Element Condition</b>	Poor condition of the concrete ramp, shown in plate 9
<b>Structure Type</b>	Seawall	<b>Report Reference</b>	AIN_HBC 006
<b>Structure Description</b>	2 tier seawall – the upper retaining wall protects gardens at the back of the properties. The lower seawall has a tarmac surface, as a Right of Way footpath adjacent to the retaining seawall – as shown in the aerial photo.	<b>Defect Co-ordinates</b>	473,974.351 105,366.383

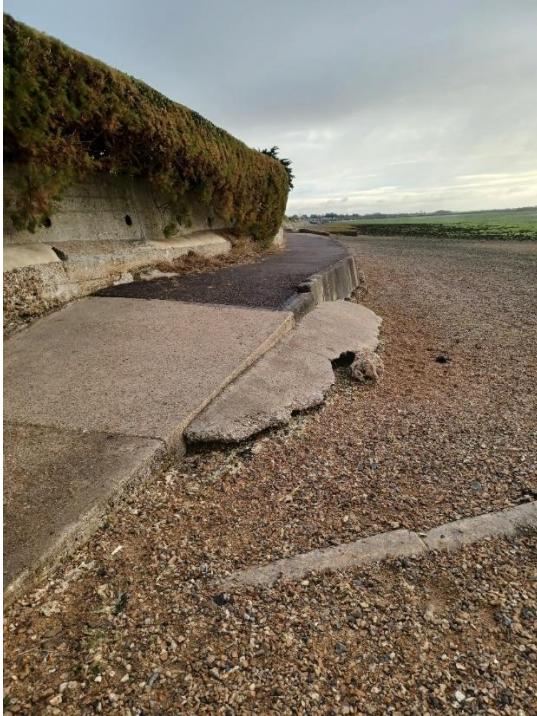
Plate 9: Beach lowering undermining ramp toe protection

Inspection Recommendation					
<ul style="list-style-type: none"> <li>• Continue with beach level monitoring at the western end of the footpath where it joins with beach</li> <li>• If beach levels drop further, consider movement of small quantities of shingle to fill void at edge of footpath under concrete slab (plate 9)</li> <li>• Long term, consider whether the ramp at the end of the footpath needs extending to reduce the risk of any undermining should the beach levels lower</li> </ul>					
Indicative Repair Cost (£)	<£5,000	<£10,000	<£25,000	<£50,000	>£50,000
