Location Name	Maisemore Gardens	Coastal Policy Unit	5a16
Report Date	06/04/2022	Coastal Policy	HTL – Hold the Line
Landowner	Private	MWF Lot	Lot 1
Maintainer	Private	Assets at Risk	Residential properties, gardens, coastal footpath
Report By	Amy Smith / Clare Dolan	Asset Overall Condition	Fair
Structure Reference	Asset475	Worst Element Condition	Poor (at western end of wall and coastal footpath)
Structure Type	Seawall and footpath	Report Reference	AIN_HBC_2122_010
Structure Description	Concrete seawall constructed in 1960's protecting properties, with coastal footpath running along the front face fronted with blockwork.	Defect co-ordinates	473974.351; 105366.383
Erosion Risk	Yes/No	Flood Risk	Yes/No

Inspection Summary

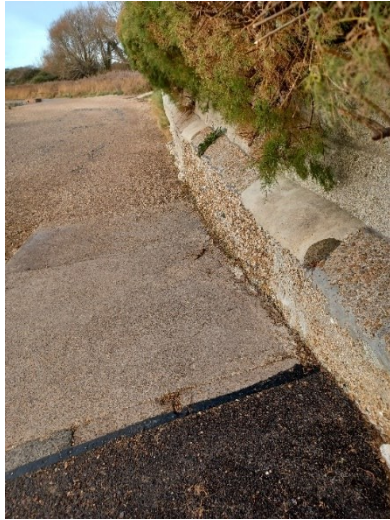
Plate 3: looking west along wall from footpath

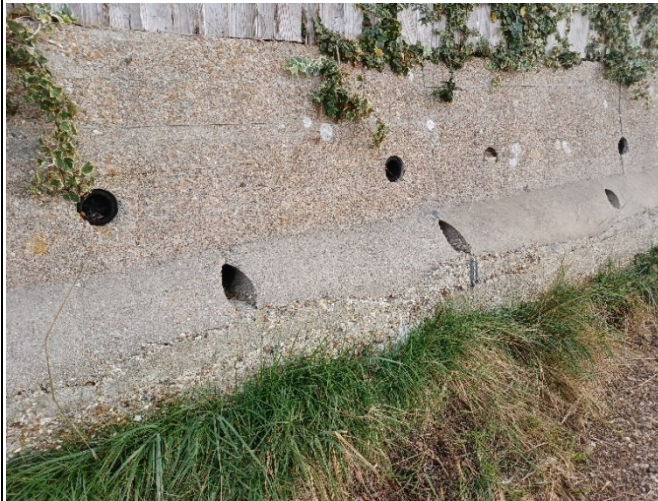
- Some repairs have been made to the defence (plate 6 and 10) following storm damage, and some water staining has been identified from drainage pipes.
- Some spalling of concrete face of the seawall identified towards the western end of the structure, past the end of the footpath (see plate 11), where beach levels have lowered over time. Undermining of the seawall at this location has also been identified – plate 10.

Plate 4: drainage holes in seawall

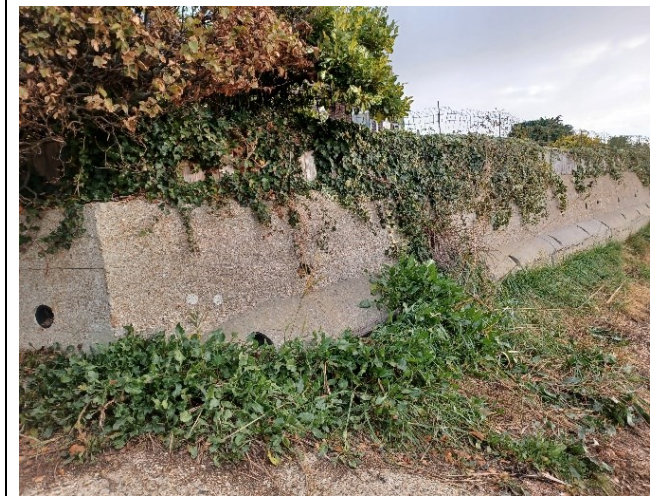
Plate 5: western end of seawall

- Continue with beach level monitoring in front of western end of seawall. Maisemore Garden residents have been carrying out beach monitoring for ~7 years at the western end of the beach.
- If beach levels continue to decrease, consider the movement of small quantities of shingle to fill the void at the edge of the footpath under the concrete slab (plate 9)
- Should the undermining of the seawall continue, consideration should be taken by the owner for remedial options
- Longer term, consider whether the ramp at the end of the footpath needs extending further to reduce the risk of any undermining should beach levels lower

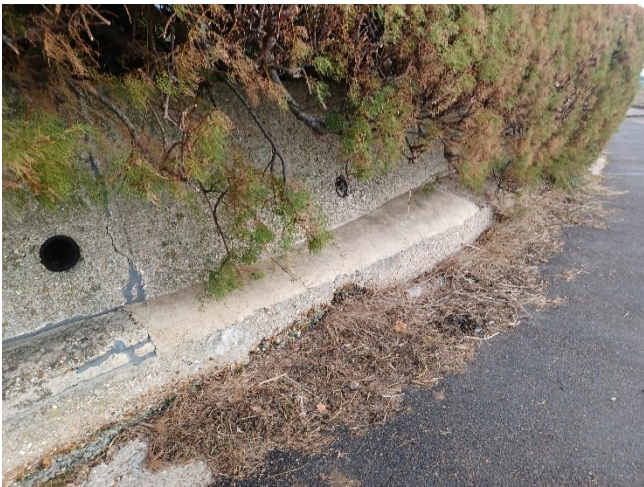
- Seawall in fair condition along majority of the length. Some vegetation growth identified over the wall – from the visual inspection this does not appear to be causing damage to the structure.

Plate 6: vegetation over top of seawall

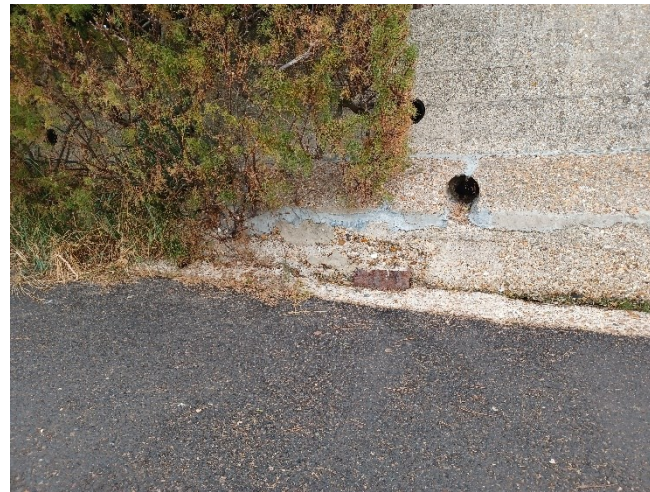
Plate 7: vegetation and drainage holes over seawall

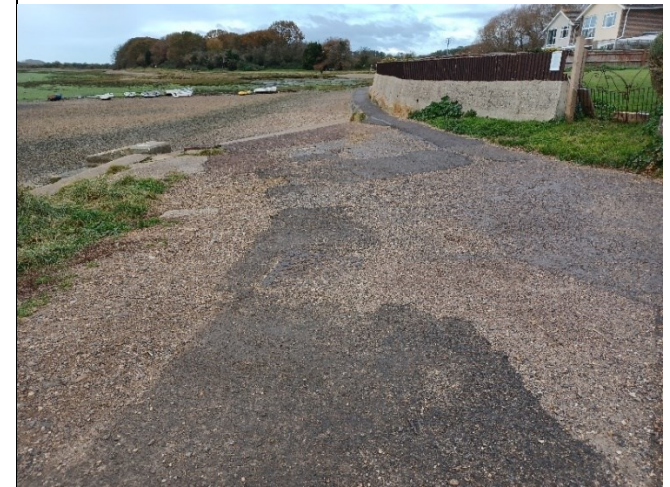
Plate 8: eastern end of seawall

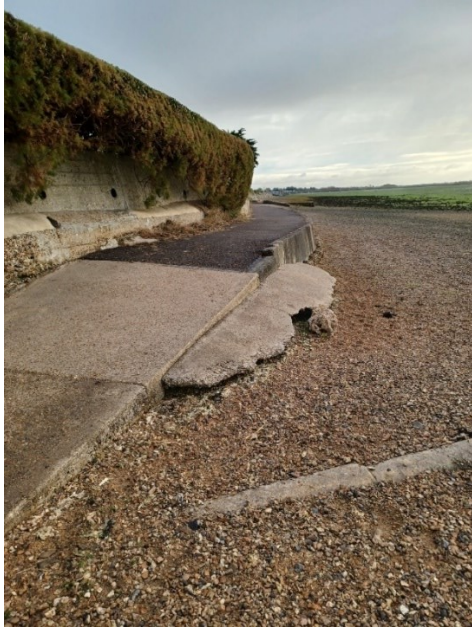
- The coastal footpath is in a fair condition, with no damage identified to tarmac surface.
- No undermining identified at western end of footpath where the path joins the beach, but some undermining noted to the seaward side of the footpath ramp on to the foreshore. Maintenance may be required to this section of footpath in the future.

Plate 9: undermining of concrete slab on footpath

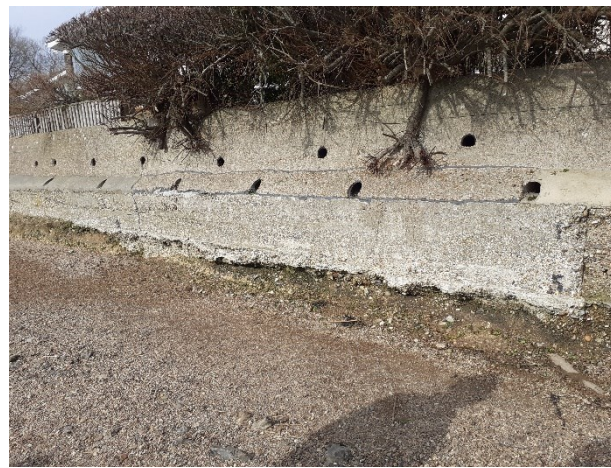
- During the visit with residents it was noted that the undermining has been ongoing as beach levels have lowered. Beach monitoring has been carried out by the residents, and results of this monitoring can be found at the end of the report for reference

Plate 10: undermining of seawall toe

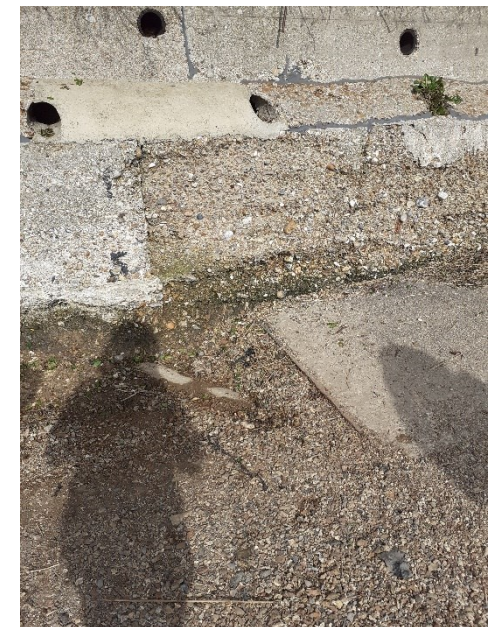
Plate 11: spalling of face and undermining of wall
