**Inspection Report:
IR/HBC/15-16/015**

Maisemore Gardens

Report number: MRR/HBC/15-16/015

Structure Type: Concrete Seawall

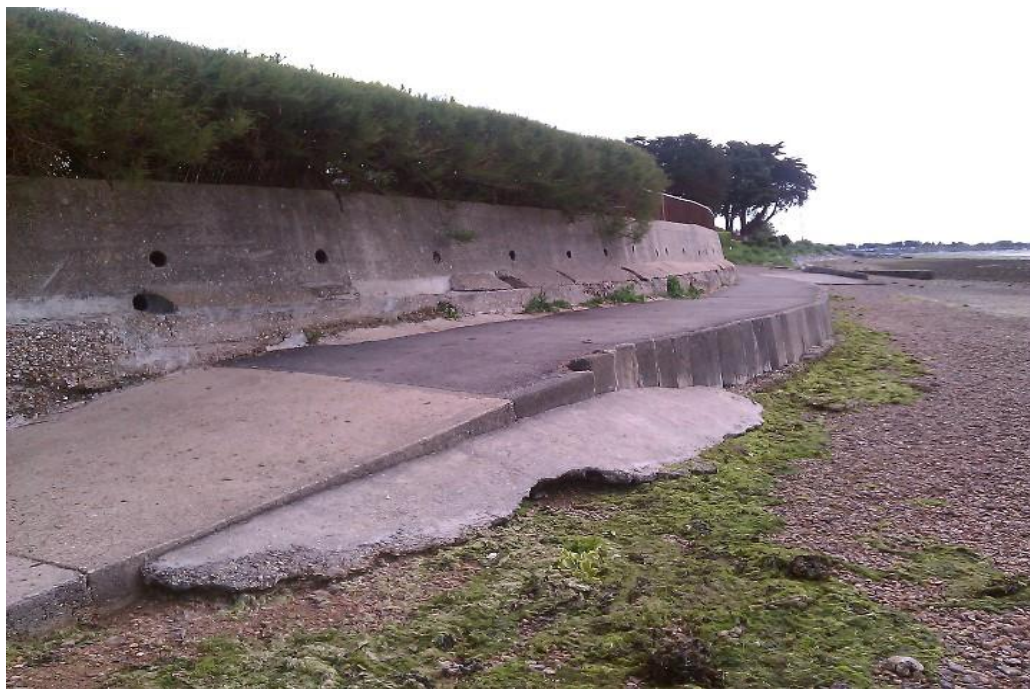
Plate 1: Raised footpath looking South East

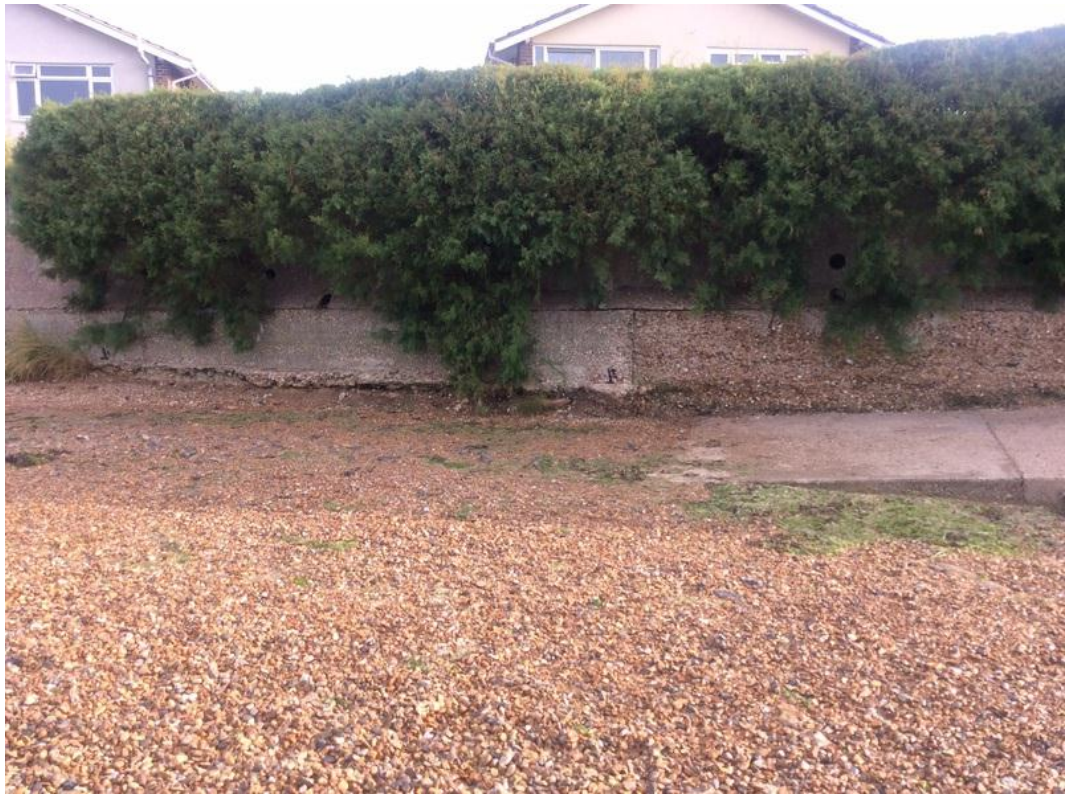
Plate 2: Seawall at foot of access ramp

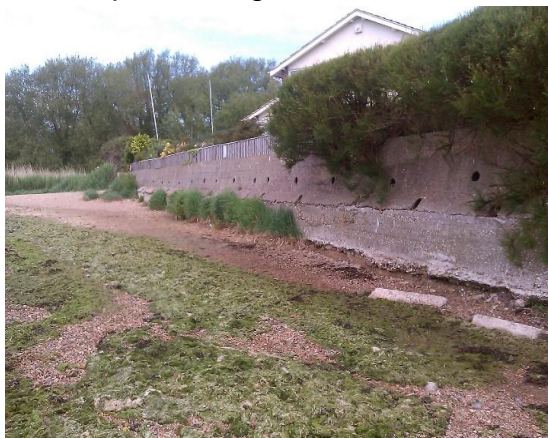
Plate 3: Seawall undercutting area

The only minor concern is at the point where the footpath ends and ramps down to the beach, there is a section of seawall approximately 5m in length where the underside of footing is visible. Repairs to this section should be considered by the Landowner.

It should be noted that the footings here were founded very shallow, as a rule of thumb the underside of a foundation in clay soil (which the soil here appears to be) would be 750mm below the adjacent ground level (GL) (see building regulations 2010 (originally 1992) approved document A pg 35).

The soil at this point is open to incoming waves at MHWS. It is noted that there is no undercutting of the foundation at time of inspection. The risk of sudden failure is low.

Routine repairs and maintenance should be considered by the Landowner.
