Location Name	Maisemore Gardens	Coastal Policy Unit	5a16
Report Date	06/04/2022	Coastal Policy	HTL – Hold the Line
Landowner	Private	MWF Lot	Lot 1
Maintainer	Private	Assets at Risk	Residential properties, gardens, coastal footpath
Report By	Amy Smith / Clare Dolan	Asset Overall Condition	Fair
Structure Reference	Asset475	Worst Element Condition	Poor (at western end of wall and coastal footpath)
Structure Type	Seawall and footpath	Report Reference	AIN_HBC_2122_010
Structure Description	Concrete seawall constructed in 1960's protecting properties, with coastal footpath running along the front face fronted with blockwork.	Defect co-ordinates	473974.351; 105366.383
Erosion Risk	Yes/No	Flood Risk	Yes/No

Inspection Summary

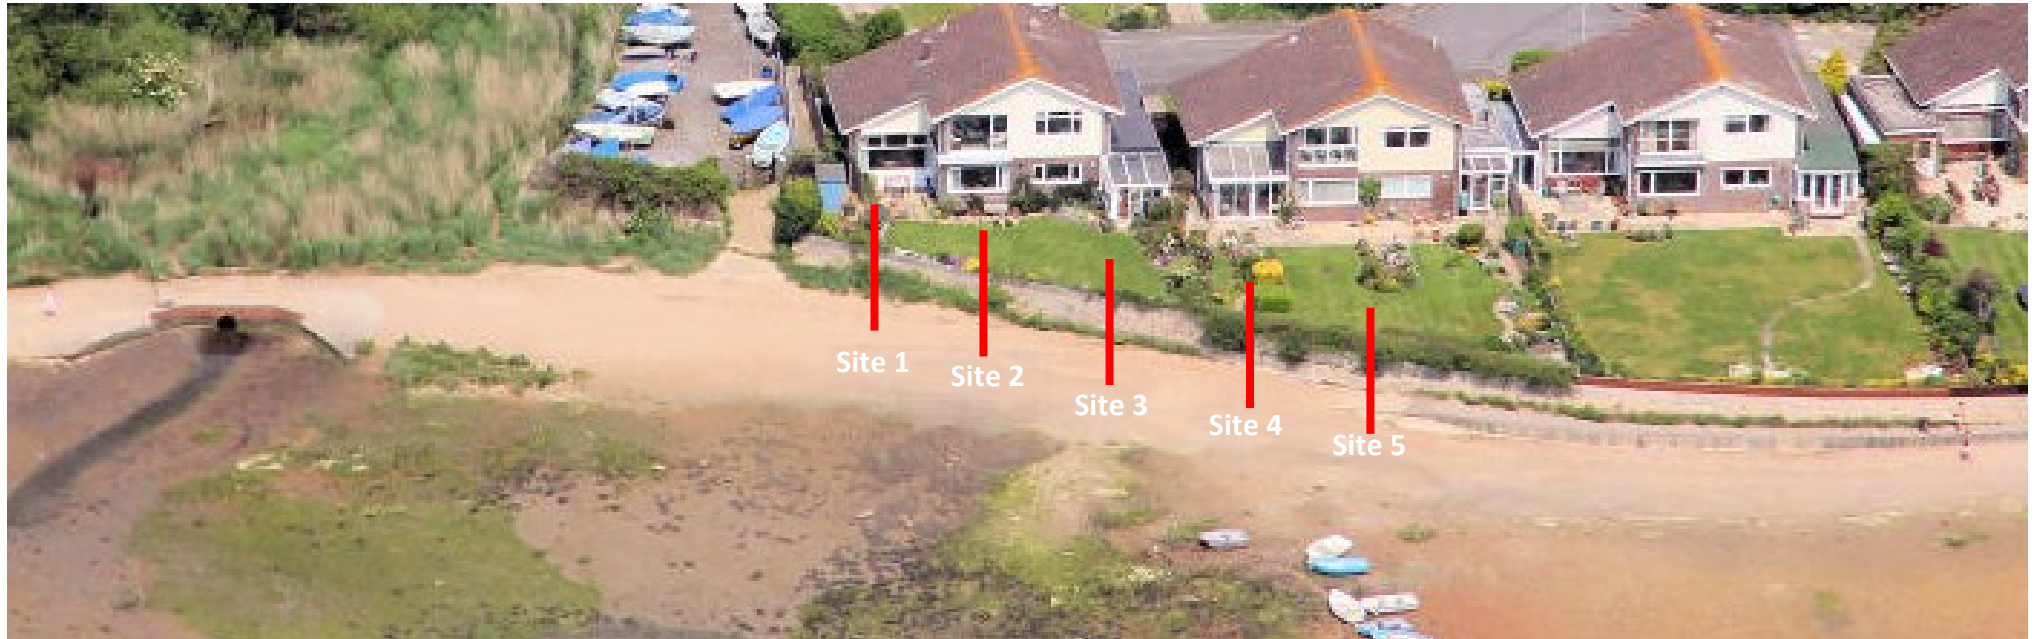
Location of measured data points (site locations approximate), along Maisemore Gardens frontage. Data provided by Maisemore Gardens residents. Photography (www.maisemoregardens.co.uk)

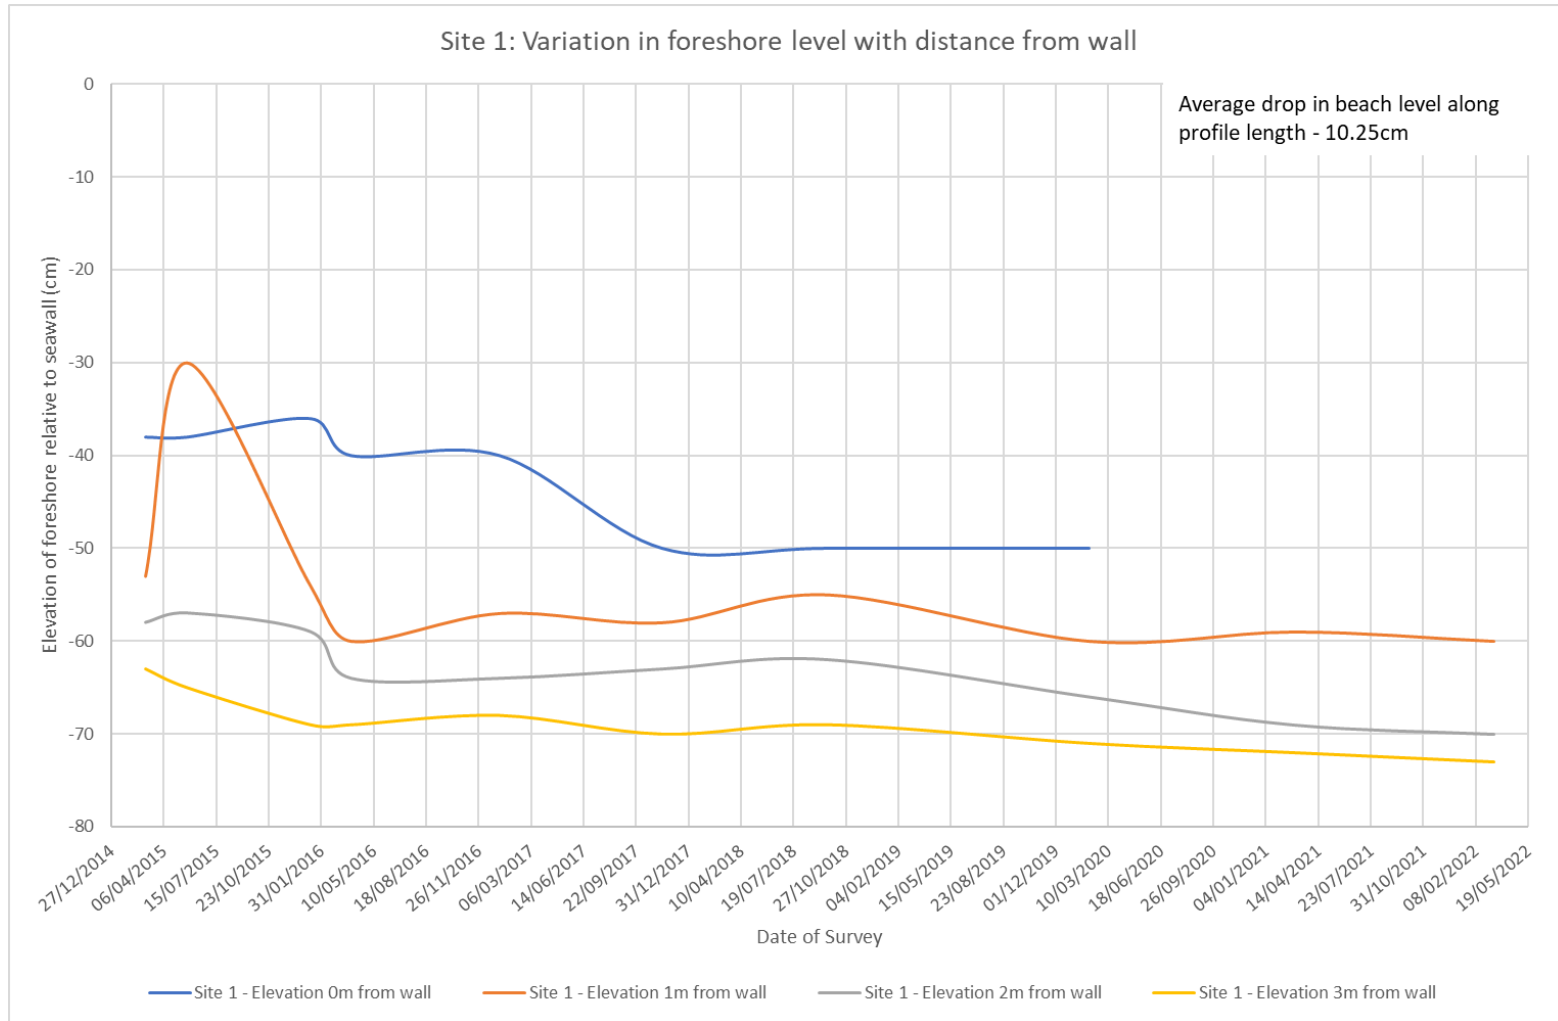
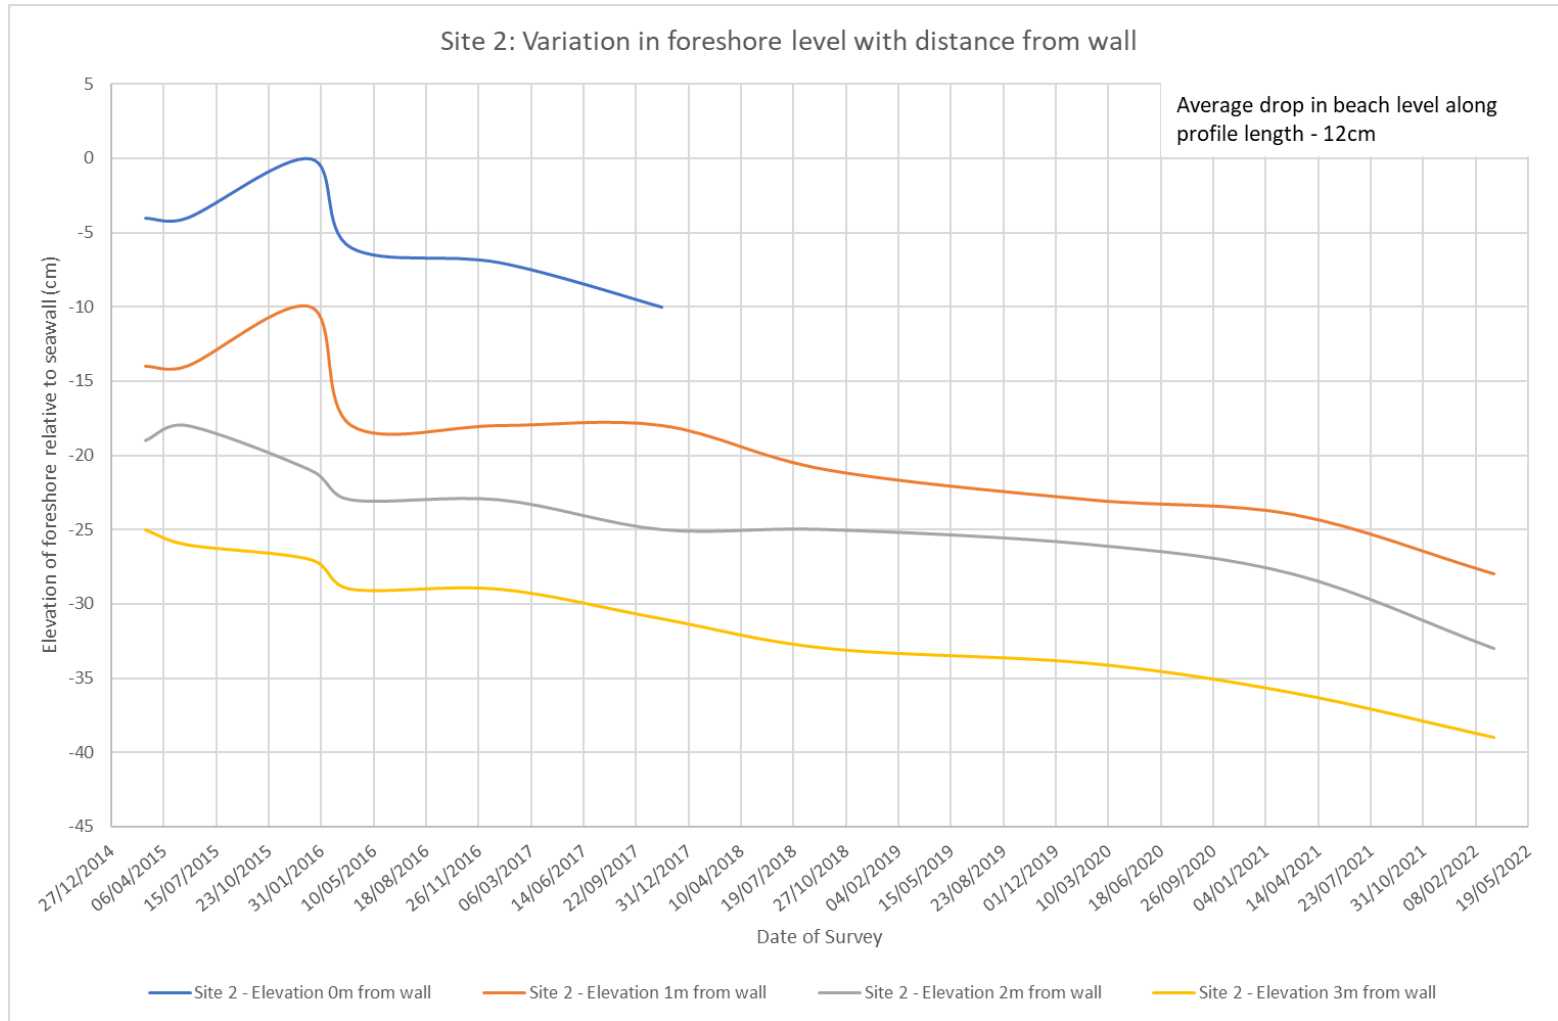
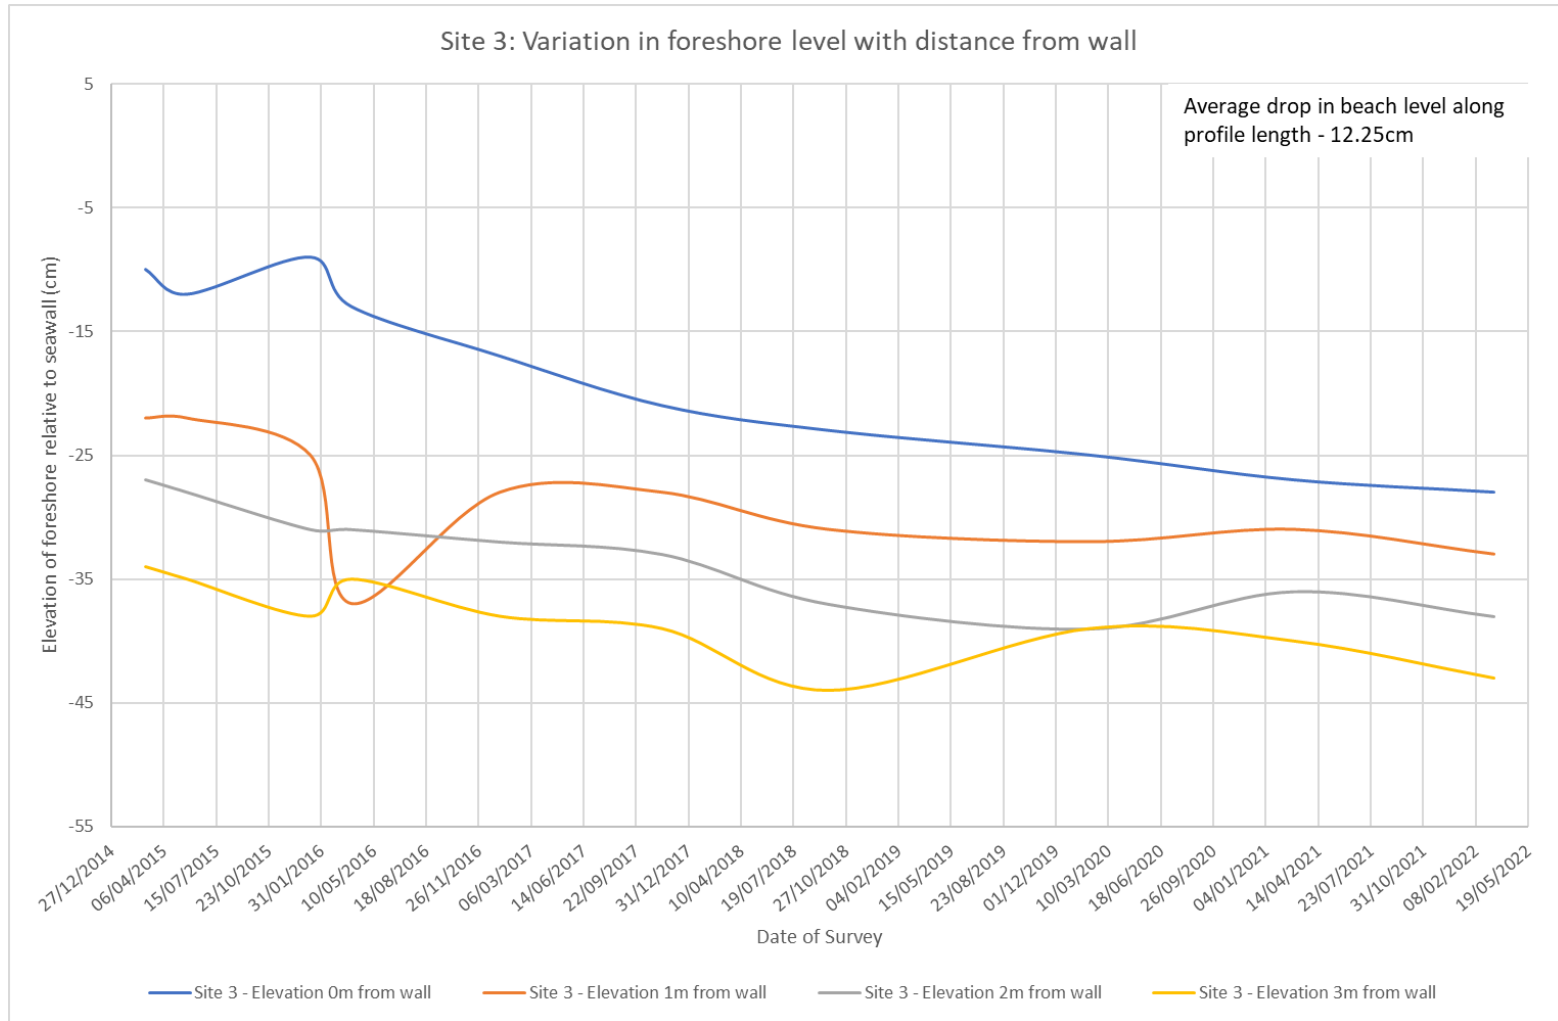
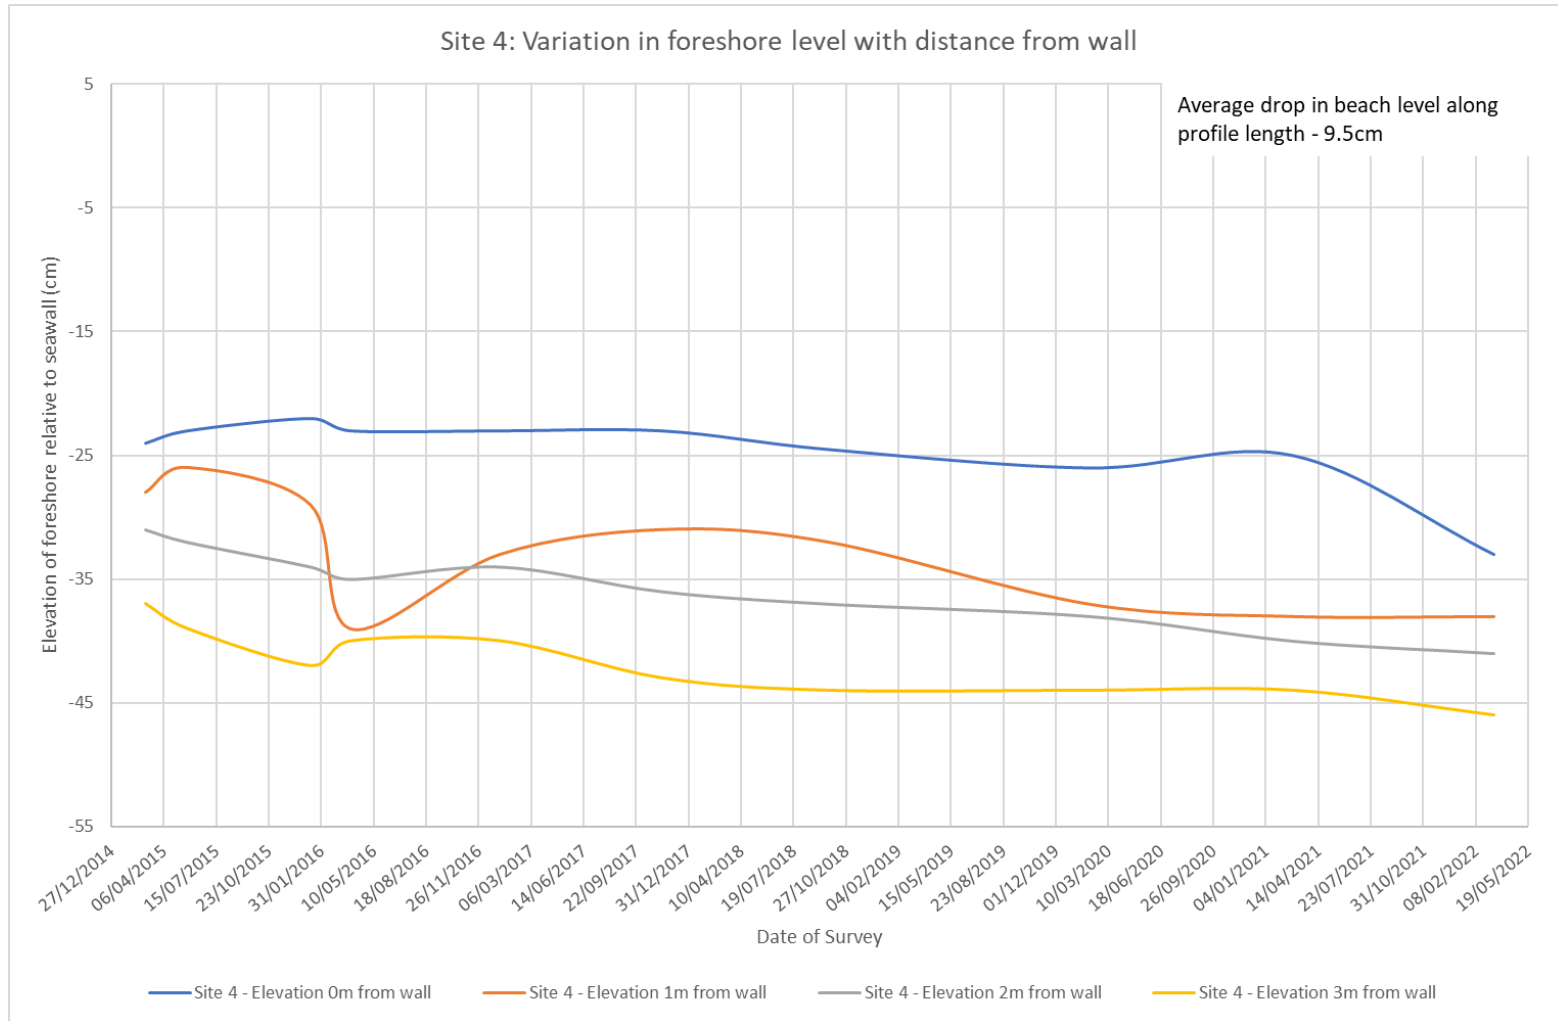
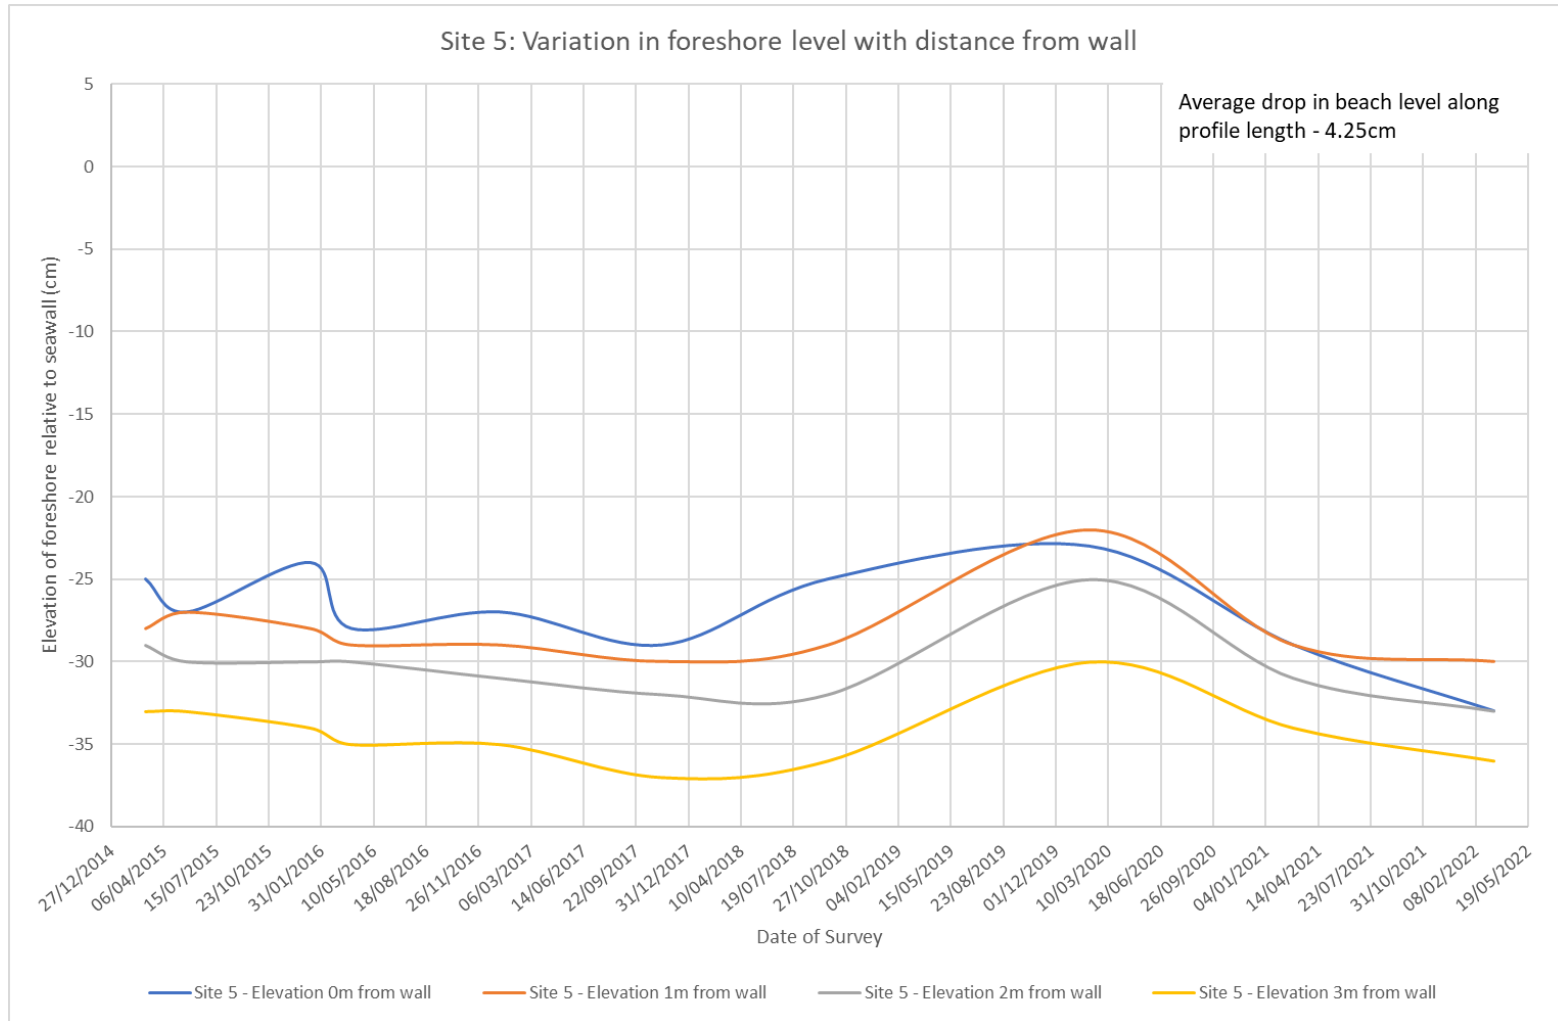
Analysis of measured beach levels provided by Maisemore Gardens Residents

- During the visit with residents it was noted that the undermining has been ongoing as beach levels have lowered. Beach monitoring has been carried out by the residents, and results of this monitoring can be found at the end of the report for reference

- Continue with beach level monitoring in front of western end of seawall. Maisemore Garden residents have been carrying out beach monitoring for ~7 years at the western end of the beach.
- If beach levels continue to decrease, consider the movement of small quantities of shingle to fill the void at the edge of the footpath under the concrete slab (plate 9)
- Should the undermining of the seawall continue, consideration should be taken by the owner for remedial options
- Longer term, consider whether the ramp at the end of the footpath needs extending further to reduce the risk of any undermining should beach levels lower
